TECHNICAL REPORT BRL-TR-3191

POWDER PACKS—
A PASSIVE APPROACH TO EXTINGUISHING
FIRE IN COMBAT VEHICLES

ANTHONY E. FINNERTY
STANLEY POLYANSKI

JANUARY 1991

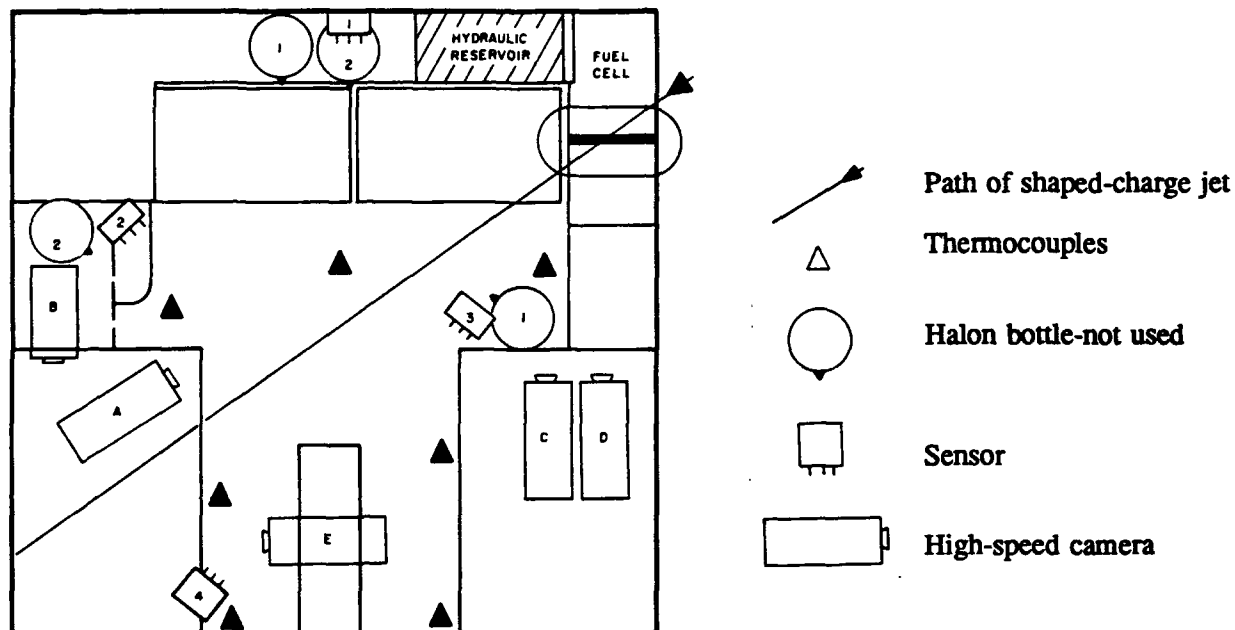
Figure B-1. Locations of Thermocouples, Cameras, Sensors, and Shot Line for First Fuel Shot.

The fire-out time inside the crew compartment was 90 ms by high-speed camera data and 107.1 ms by optical sensor data, well within the goal of 250 ms. Thermocouple data gave a maximum temperature-time integral of 941° C-second. This yields a prediction of no second-degree burns on exposed skin.

Met fire-out time criteria with no second-degree burns.

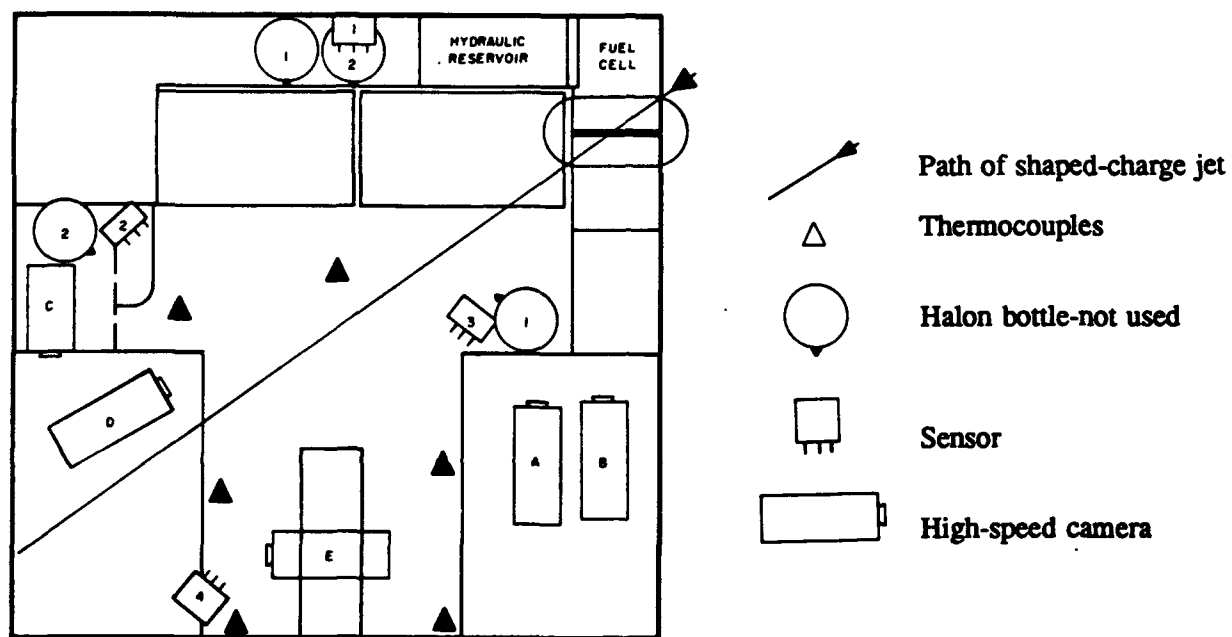
Figure B-4. Locations of Thermocouples, Cameras, Sensors, and Shot Line for Second Fuel Shot.

The fire-out time inside the crew compartment was 110 ms from high-speed camera data and 155.0 ms from optical sensor data. This was less than the 250-ms criterion. Thermocouple data gave a maximum temperature-time integral of 646° C-second. The prediction is that there will be no second-degree burns on exposed skin.

Met fire-out time criteria with no second-degree burns.

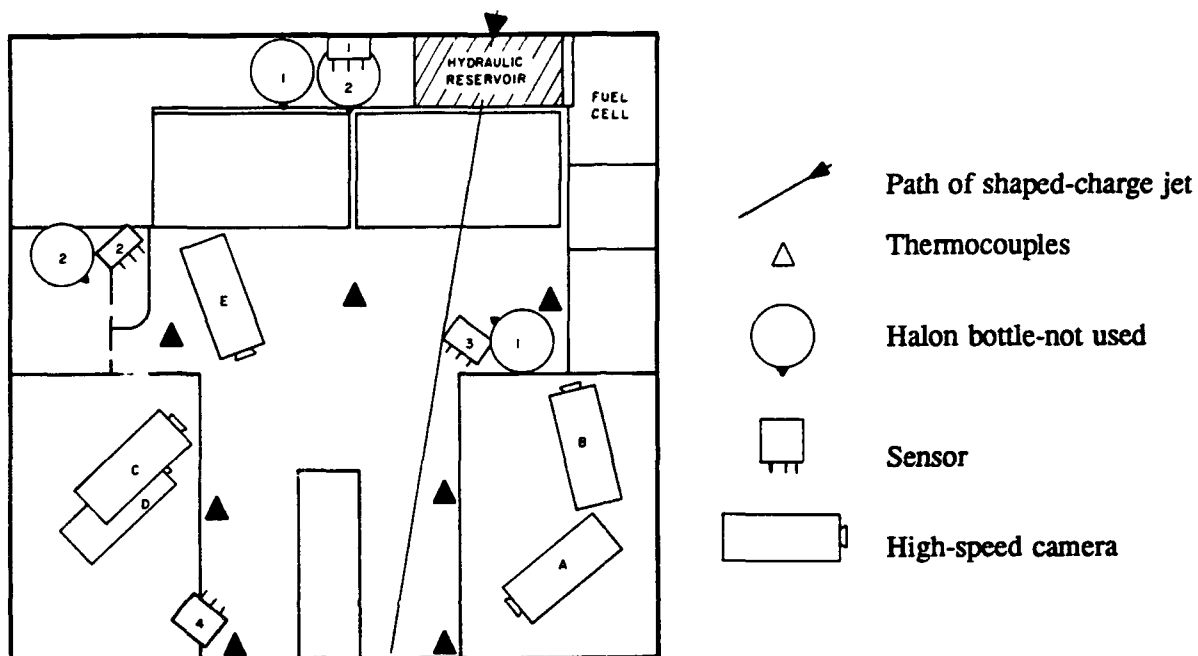
Figure C-1. Locations of Thermocouples, Cameras, Sensors, and Shot Line for First Hydraulic Fluid Shot.

The fire-out time from high-speed camera data was 199 ms. The optical sensors failed to give a LF signal; therefore, they did not see the hydraulic fluid fire. This may have been caused by the unusual location of the hydraulic fluid fire, close to the roof section of the vehicle. The fluid ejected upward did not have much powder with it, due to the limited breaking of the top powder pack. The sensors may not have had a good field of view of this fire. However, the 250-ms criteria was met for fire-out time.

Thermocouple data gave no significant data. This is probably because the burning fluid was mainly close to the roof. The fluid that exited the reservoir, following the jet, was stopped by the ammunition rack. There would have been no second-degree burns on any crew member's exposed skin.

Met fire-out time criteria with no second-degree burns.

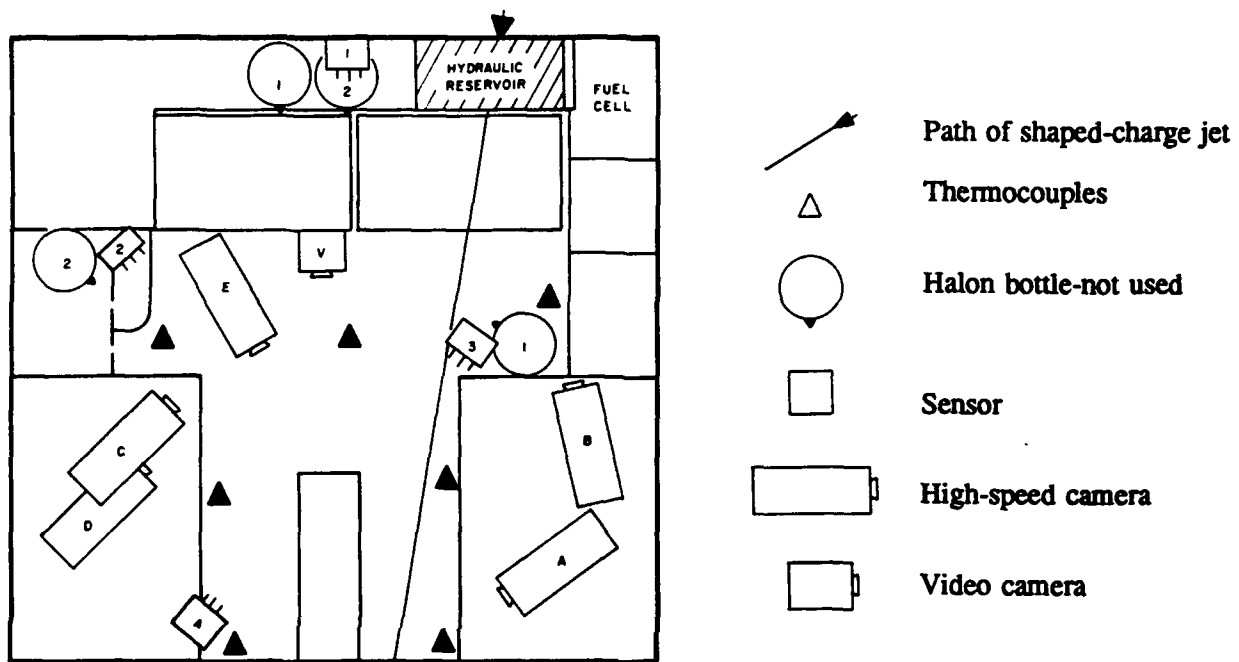
Figure C-4. Locations of Thermocouples, Cameras, Sensors, and Shot Line for Second Hydraulic Fluid Shot.

This test did not meet the fire-out time criteria of 250 ms. Internal video observed a fire near the roof for approximately four seconds. Fire-out time from the optical sensors was over 2000 ms. This was due to the lack of powder near the roof where the fluid burned. This test of a set of 6.4-mm powder packs was considered a failure.

The thermocouple data were more encouraging. The maximum temperature-time integral was 586° C-second. The assessment was that no crew member would have suffered second-degree burns on exposed skin. Again, it was probably due to the location of the fire near the roof. The ammunition rack effectively prevented most of the hydraulic fluid from reaching crew positions. Figure C-4 gives locations of cameras, thermocouples, sensors and their data, along with the shot line. Views of the powder packs before and after the shot are given in Figure C-5 and C-6.

Did not meet fire-out time criteria, but no second-degree burns.
